UPPER AND LOWER DAMS

✓  
**PHASE I INSPECTION REPORT**  
**NATIONAL DAM INSPECTION PROGRAM**

National Dam Safety Program

(NDI No. PA 00389,

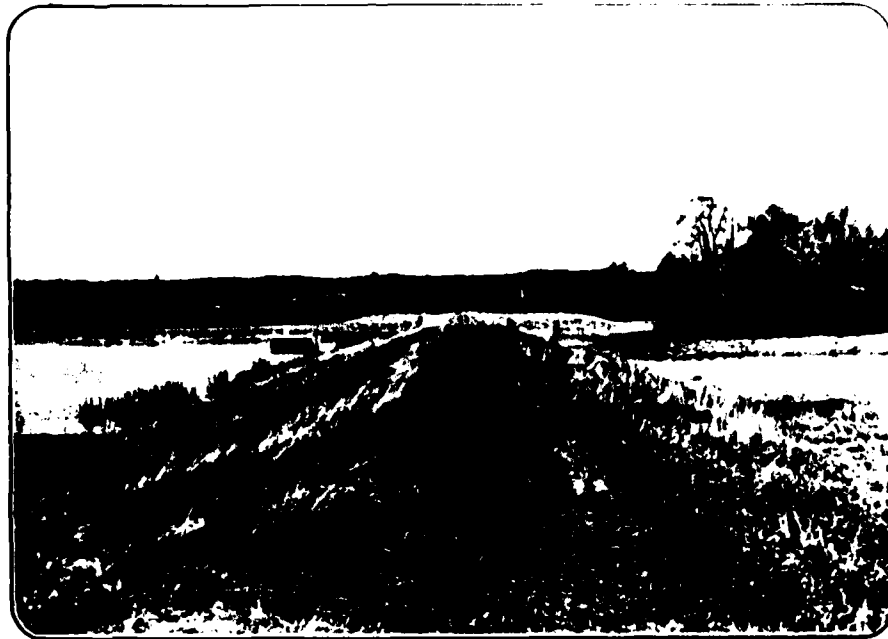
**Overall View of Lower Dam from Right End of Embankment**

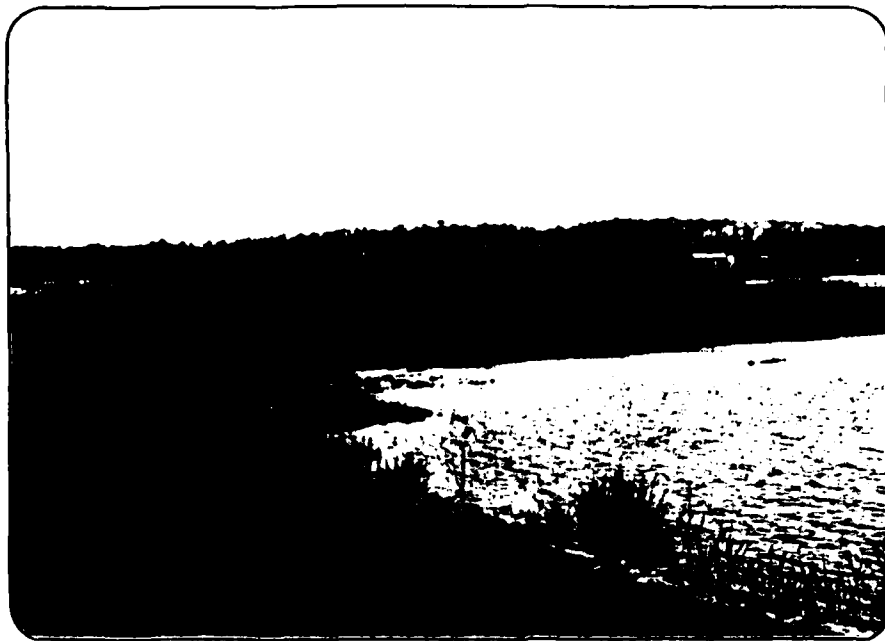
**PHOTO 3. View of Entrance to Right Emergency Spillway of Lower Dam**

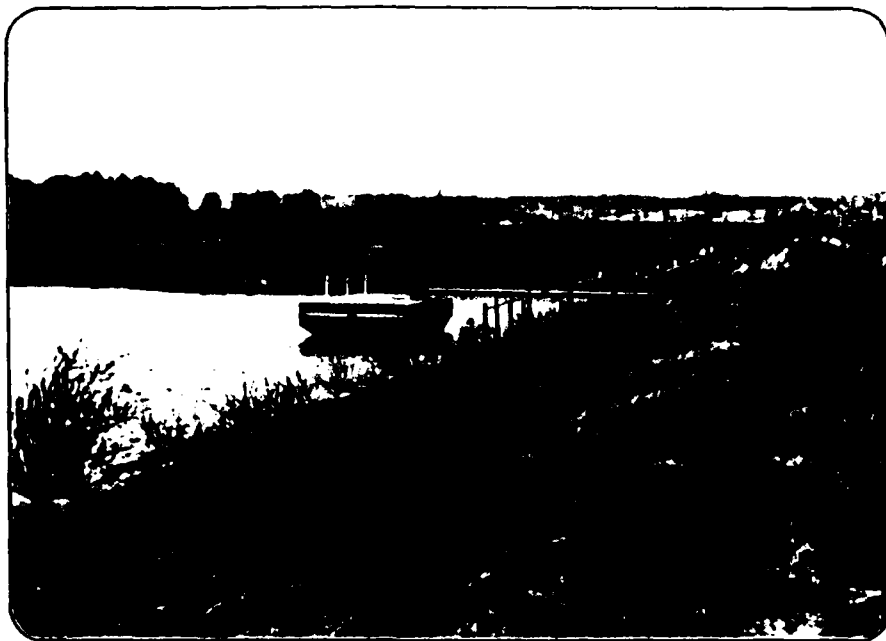
**PHOTO 5. View of Intake of Principal Spillway of Lower Dam**

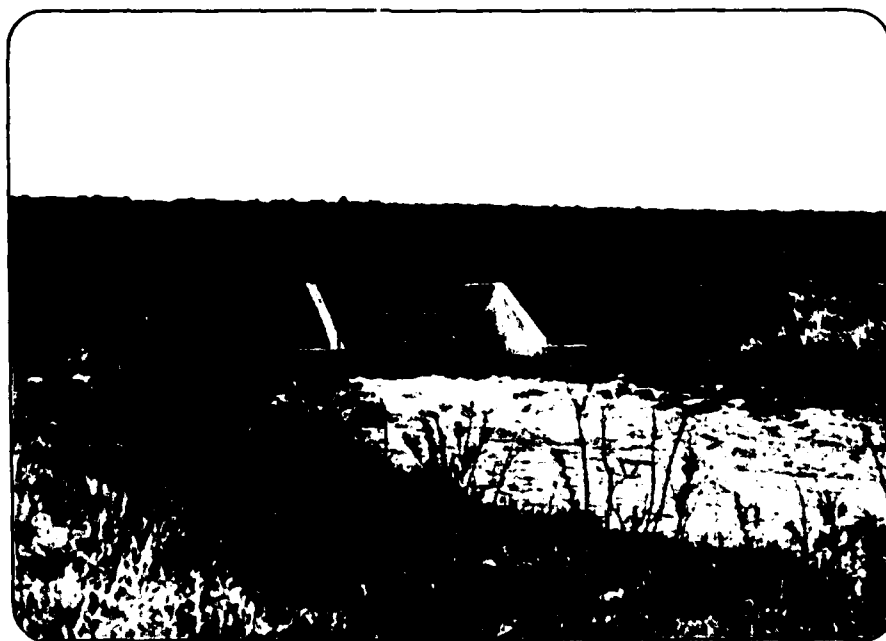
**PHOTO 6. View of Outlet Structure of Principal Spillway of Lower Dam**

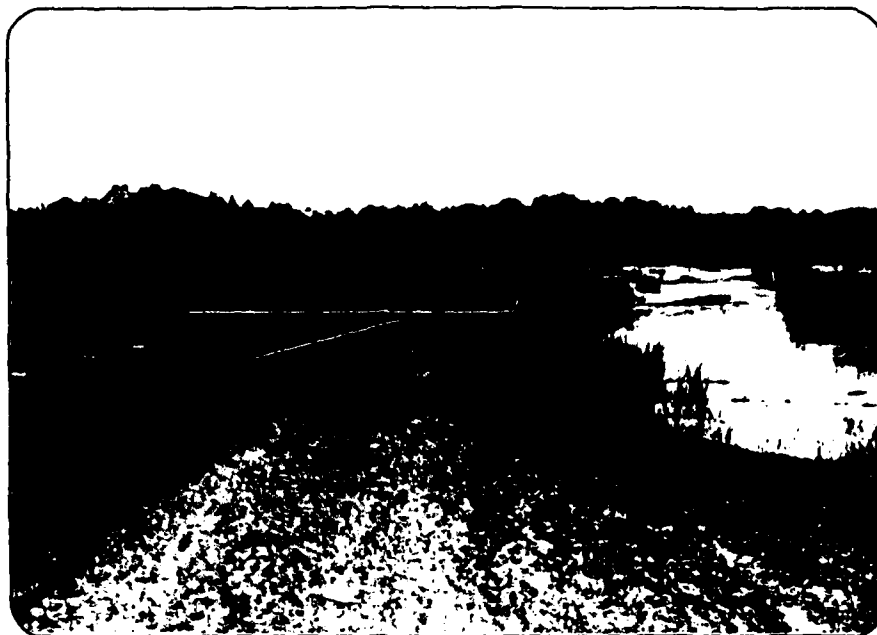
**PHOTO 7. View of Emergency Spillway of Upper Dam Looking toward Dam**

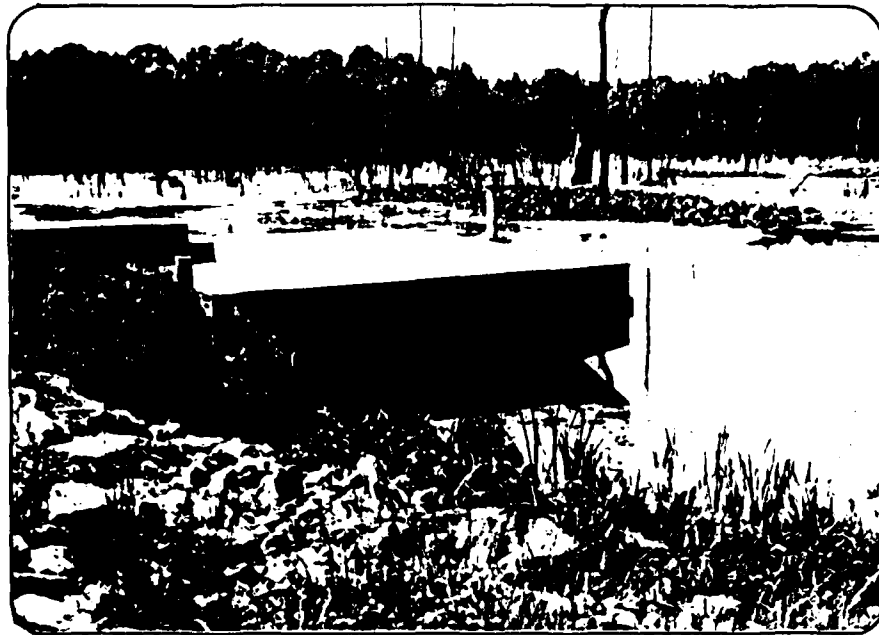
PHOTO 9. View of Intake Structure at Principal Spillway of Upper Dam

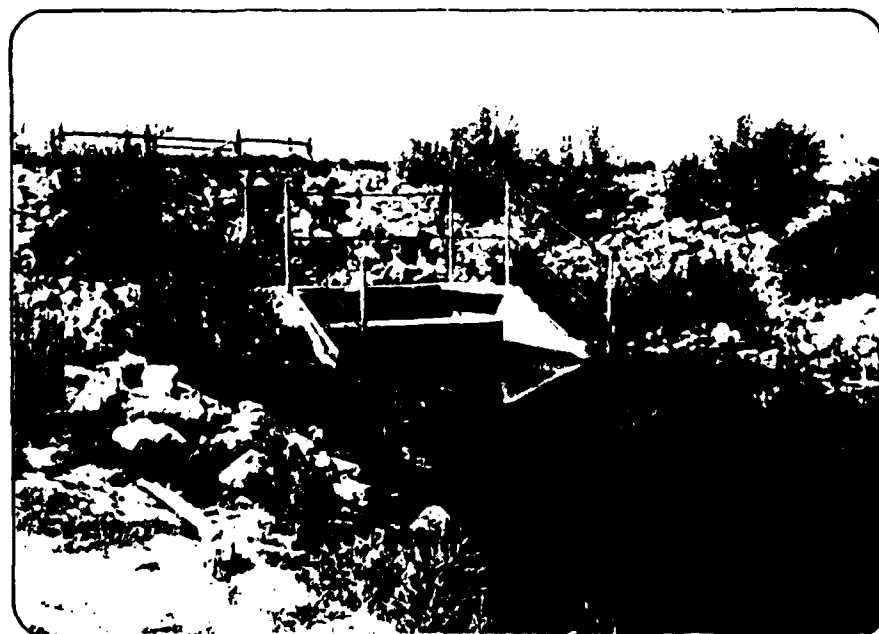
- c. Appurtenant Structures - These structures were in good condition except for some chipped concrete (probably the result of vandalism) on the impact basin for Upper Dam.

Some minor areas were observed where the concrete was chipped. This is apparently the result of vandalism.

PHOTO 10. View of Outlet Structure of Principal Spillway of Upper Dam

The inspection revealed only one deficiency which should be corrected immediately, namely, the repair of the chipped concrete on the impact basin of Upper Dam.

These areas of the concrete should be repaired.
